179
Defects in Plumbing
and Drainage Work

described by Francis Vacher
upwards of 100 illustrations

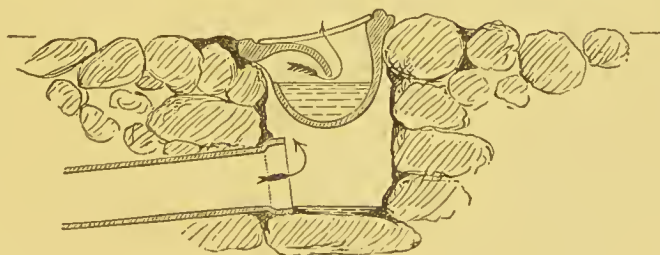
FIG. 16.

A defect less frequently met with is illustrated in Fig. 16. This trap, like all small D traps, holds too little trapping water to be secure, even had it been properly set. However, the workman who fixed it had done his work so negligently that, owing to uneven setting, the water seal was completely broken.

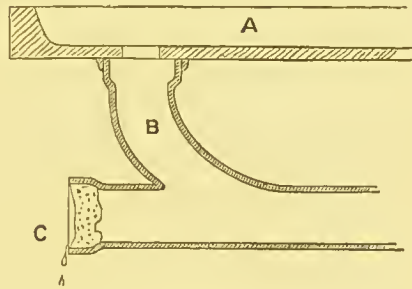
FIG. 22.

Fig. 22 shows a sink in the basement of a house rented at £45. The sink had been fitted with a bell trap, but this was lost. On making an examination beneath the stone it was found

that the sink waste was a 4in. earthenware junction pipe. A is the sink, B the pipe, and C the end which was imperfectly stopped, and through this stopping the foul water was leaking on the floor.

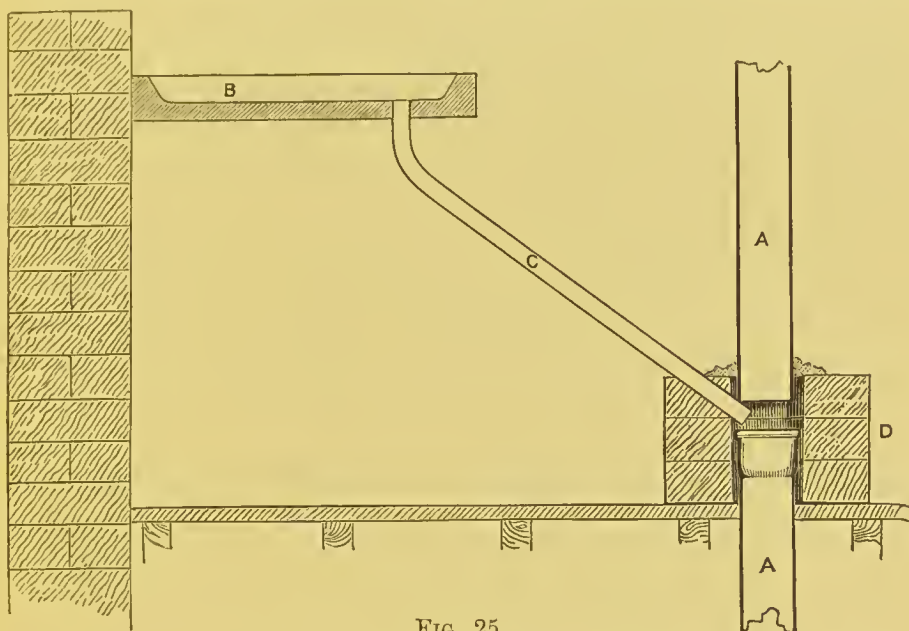
FIG. 25.

Fig. 25 represents an instance of badly-planned and badly-executed work. The defects will be obvious at a glance. A is an iron soil pipe from the closet above, running through the centre of the house to the drain in basement; B is a sink situated on an upstairs landing; and C is the sink waste pipe directly connected with the soil pipe A. It will be seen that the upper length of the soil pipe is not placed well down in the socket of the length of soil pipe below, and properly jointed, but that there

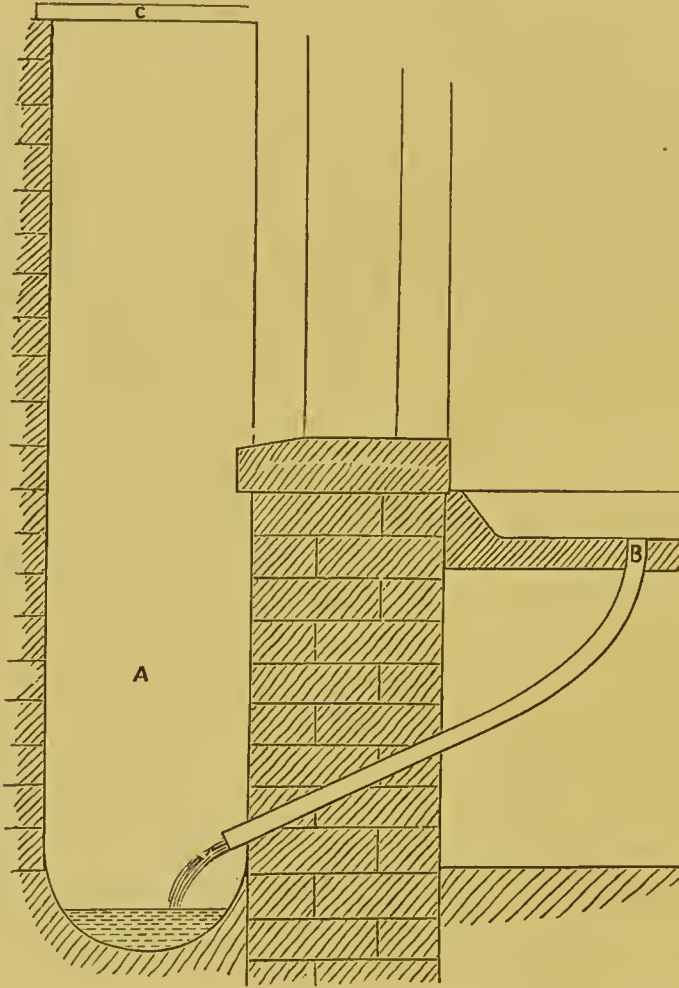
FIG. 27.

Fig. 27 shows a sink in the basement drained into an air drain. The house in which I noticed this defect was a hand-

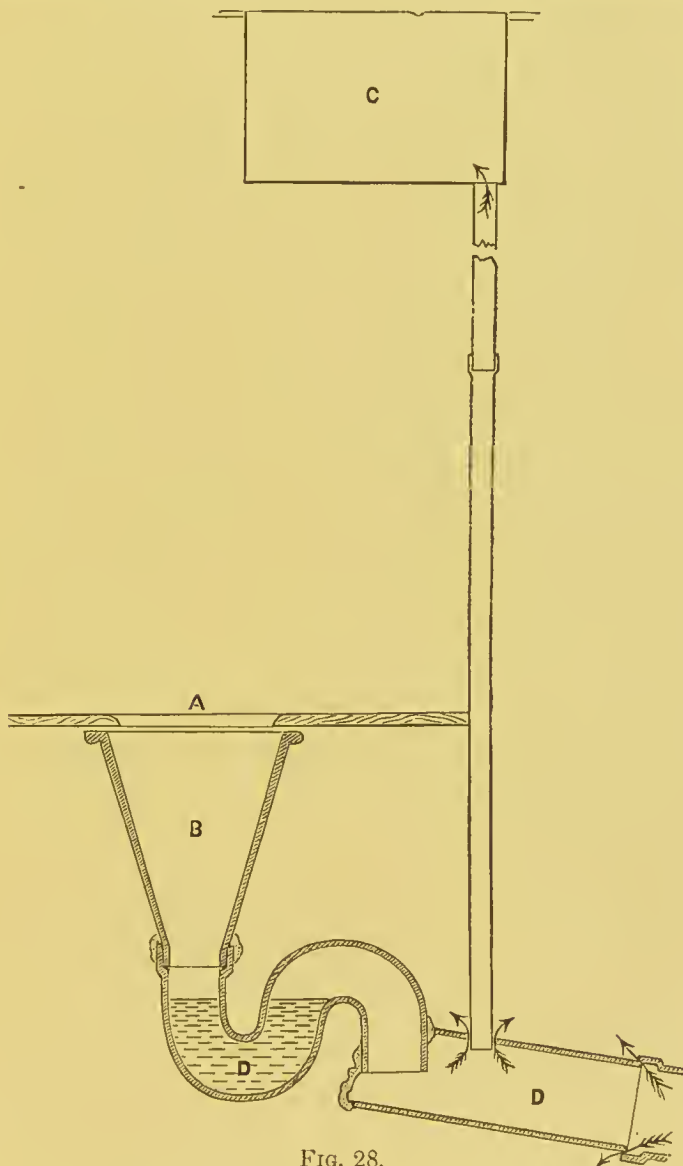
FIG. 28.

Fig. 28 shows what was discovered at a smaller suburban villa rented at £40. There was a complaint of effluvium nuisance, especially in the basement, and the examination of the premises was accordingly begun in the closet in the basement. Here was a basin of the usual pattern, properly connected to a 4in. glazed earthenware trap, and this again was connected to a 6in. glazed earthenware pipe, as indicated in the cut, the joint being not a workmanlike one, but made with cement, and apparently tight. The joint at the other end of the 6in. pipe

was bad all round, and in the upper part of this 6in. pipe a hole had been drilled to receive a 1½in. cast-iron waste pipe. The cast-iron pipe was quite loose, and could be moved freely from side to side. Above was a butler's pantry sink, the lead waste pipe of which was directly connected with the cast-iron pipe. A is the closet seat, B the basin, D and D the trap and drain pipe, and C the sink. The escape of foul air was from the defective joint in the drain, the hole drilled in the drain, and the sink in the butler's pantry.

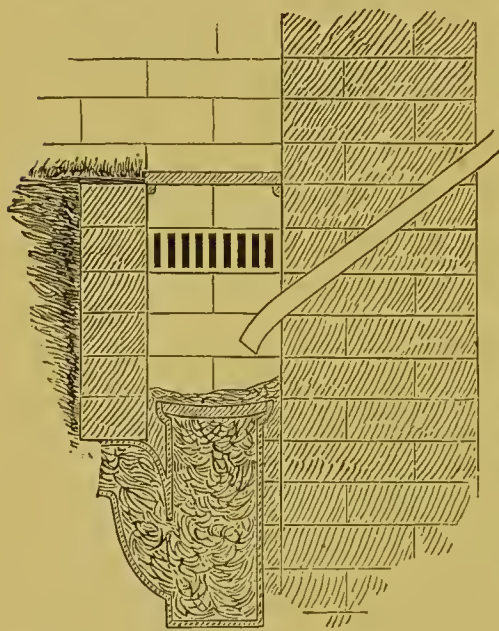
FIG. 29.

Fig. 29 illustrates a curious defect in another villa resi-

dence. Complaint was made that water was coming in through the external wall of a room in the basement used as a washhouse. A plumber was sent for, and it was found that the water came from an iron ventilator in the external wall, which had been put in to ventilate the basement. On the outside of the grating was a small area which had been made to receive the gulley trap on which the sink waste pipe delivered. As this area was covered by an iron grating, no attempt to cleanse it, or the trap it contained, had been made for a long time. The result was that the trap got filled to the brim with fat and other offensive matter; and then the foul water discharged by the sink waste pipe filled the area till it reached the level of the ventilator, and overflowed into the house.

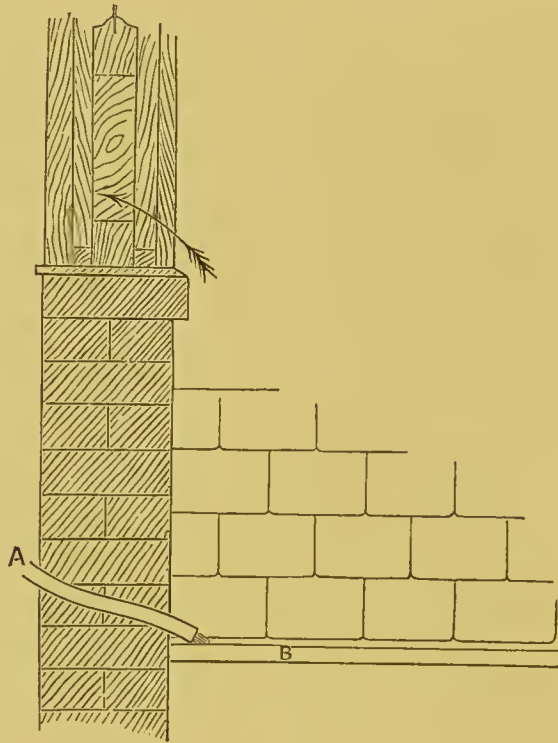
FIG. 31.

Fig. 31 shows a comparatively common defect. It is from a large building used as a hospital. A is a waste pipe from two hand-basins, discharging on a roof gutter B. The foul water from A runs along the open gutter for five feet before it reaches a downspout. Two feet above this gutter, which is ordinarily in a very foul state, is a window. Of course the proper practice

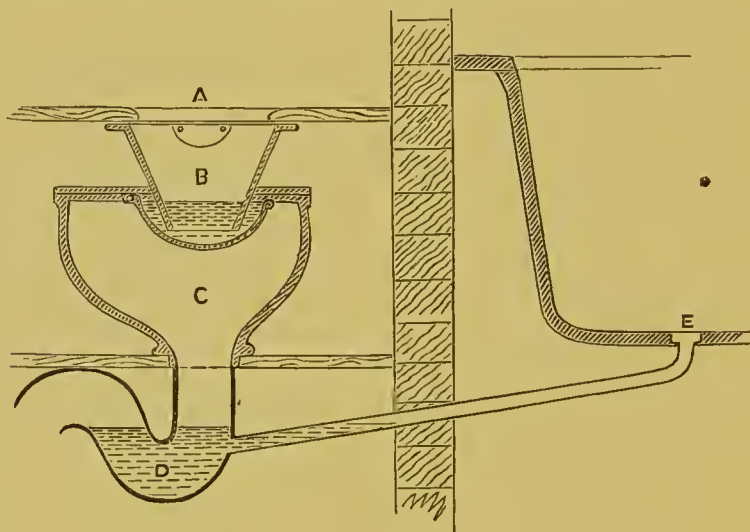
FIG. 35.

Fig. 35 is a section of a closet, showing also a portion of a bath in an adjoining room. As will be seen, the bath waste is taken into the closet trap. There was a complaint of an effluvium from the bath waste, and when the closet was used there were puffs of foul air from the waste pipe. In the cut A is the closet seat, B the basin, C the container, D the trap, and E the pipe wrongly brought into the trap.

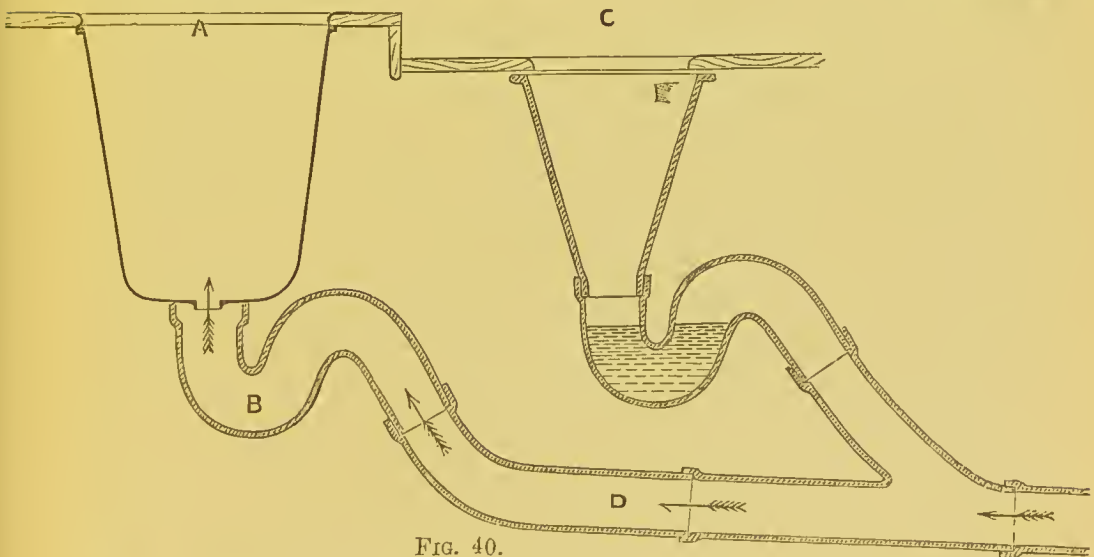
FIG. 40.

Fig. 40 shows in section a bath and closet situated in a small outbuilding erected as a "lean-to" in the rear of a dwelling-

house. There was no other bath or closet in the house, and complaint was made of a very great effluvium nuisance in the outbuilding. The nuisance was verified, and its cause was soon apparent. I found the bath full of lumber, and the taps

designed for the hot and cold supply twisted and immovable. The tenant said the bath had never been used. Of course, the 4in. earthenware pipe trap beneath was dry; and although the closet trap was acting, there was nothing to prevent the drain gases and effluvia having access to the room. A represents the bath, B the trap to the same, C the closet, and D the drain. In designing the house it was a mistake to put the bath in an outhouse, access to which could only be obtained by crossing a yard. Such a bath would almost certainly be neglected. However, it would have been quite easy to have made the bath waste deliver on the gully in the yard, and then, whether the bath were used or not, no nuisance could have arisen.

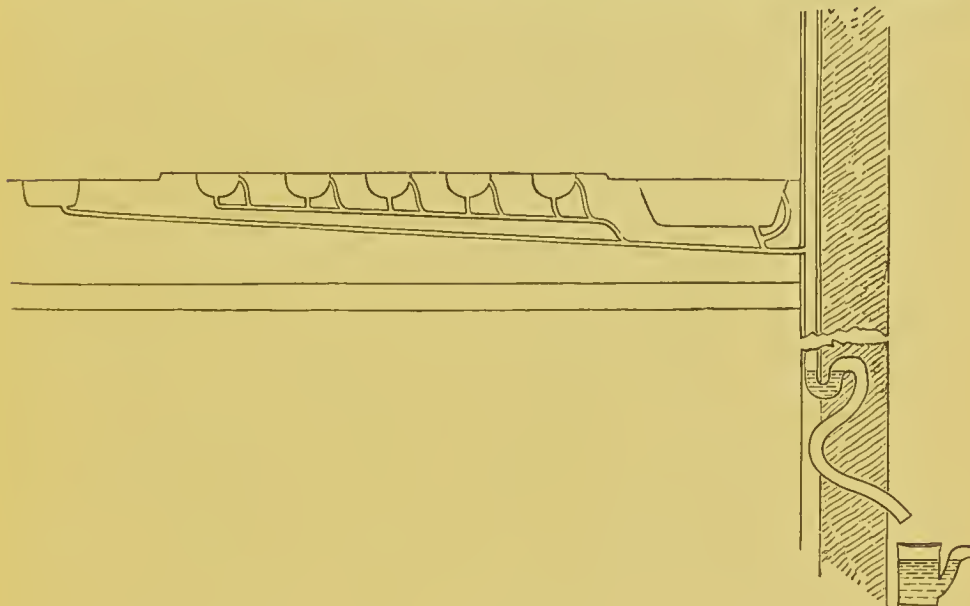
FIG. 42.

Fig. 42 represents a housemaid's sink, row of hand basins, and a bath, with waste pipes and overflow pipes discharging

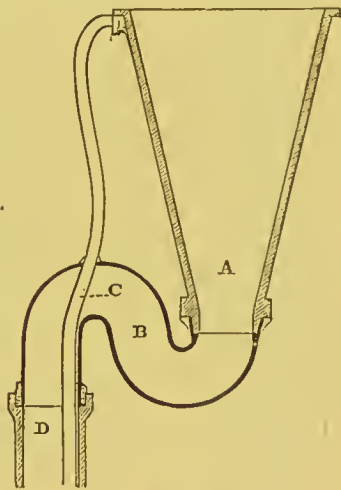
FIG. 43.

Fig. 43 shows the arrangement. A represents the basin, B the lead trap, C the lead service pipe, and D the earthenware soil pipe. Where the service pipe came through the trap it was carefully soldered round, but where it entered the earthenware

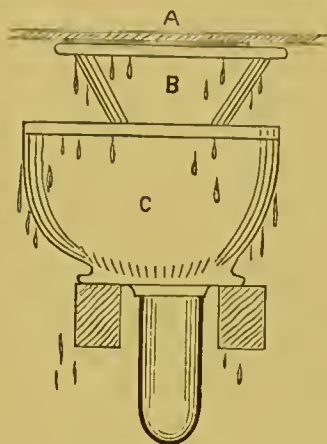
FIG. 46.

Fig. 46 represents an old pan closet as seen from the front. It was the only closet in a suburban villa rented at about £40. A nuisance was complained of, and on removing the wood which concealed the basin and container, both were found to be in a most filthy state, as well as the parts beneath. There was no

nected, &c.—but as unfortunately the local byelaws do not require safes to be placed beneath closets, a *saving* had been effected in this respect. This is not the only nuisance I have found due to this cause, but certainly the worst. In the cut, A is the seat, B the basin, and C the container.

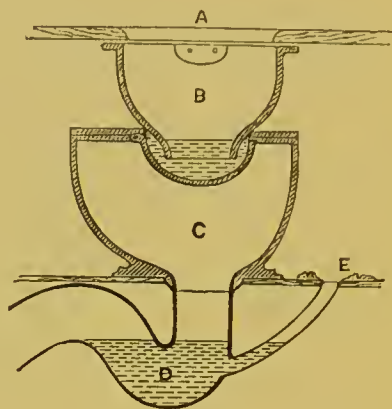
FIG. 47.

Fig. 47 shows a closet in which the lead tray just referred to was provided, but a nuisance had been caused through draining the tray into the closet trap. The surface of the safe around the drain was filthy, showing that foul matter had been pumped up from the trap each time the closet had been used. A is the

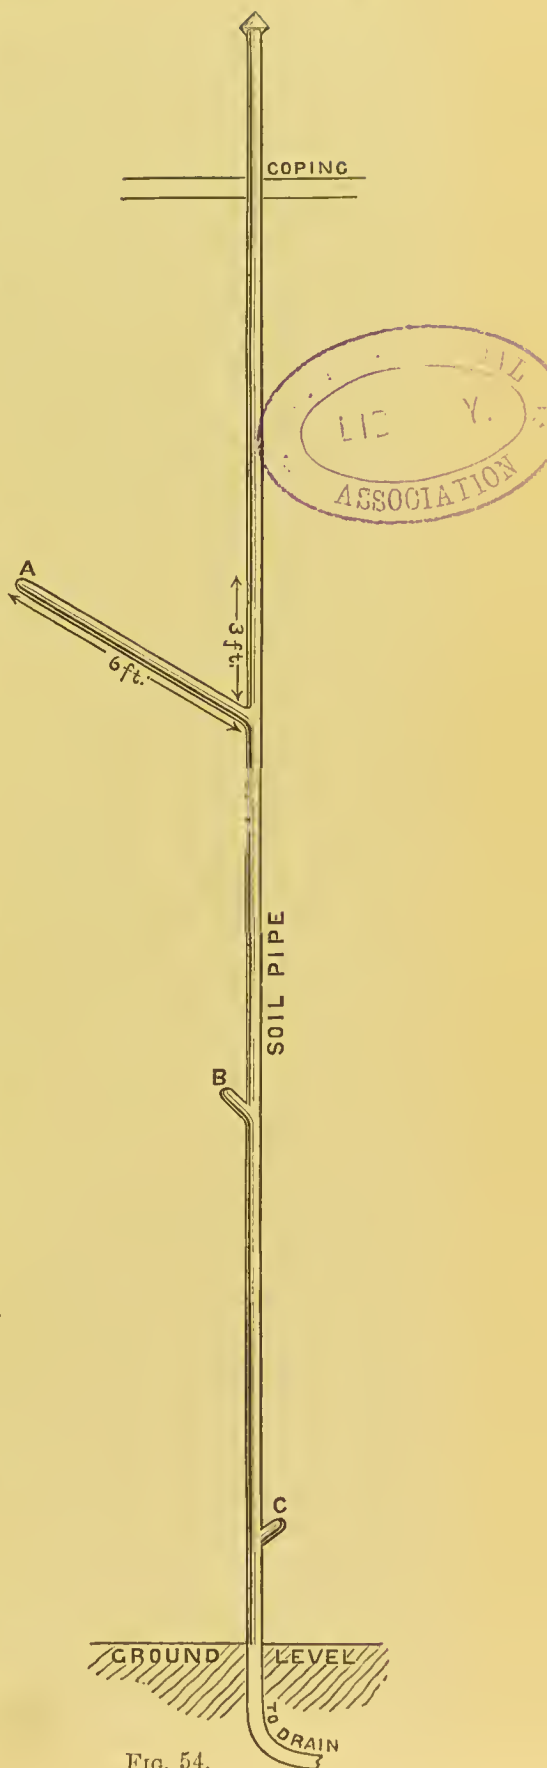
FIG. 54.

Fig. 54, with a description of the defect represented therein, was sent me by a correspondent. Complaint was received from a large boarding school, and my correspondent made a careful examination of the sanitary arrangements generally. On applying the smoke test it was found that smoke issued from the basin of the

watercloset at the top of the house, owing to the seal of the trap of this watercloset having been broken. How this had happened was not easy to discover. The trap was filled, and then the closet was flushed in the usual way. It was a powerful flush, but the water seal of the trap was only reduced from $1\frac{3}{4}$ in. to $1\frac{1}{2}$ in. Further inquiry, however, elicited the fact that the house slops (including water from sponge baths, &c.), amounting to about twelve pailfuls, were every morning emptied down the closet referred to, one pailful after another in quick succession. By way of experiment a pail of water was discharged into the basin of the closet quickly, and the normal depth of water in the trap was found to be reduced three-quarters of an inch. Another pail was discharged in like manner, and the depth of water in the trap was reduced half an inch more. A

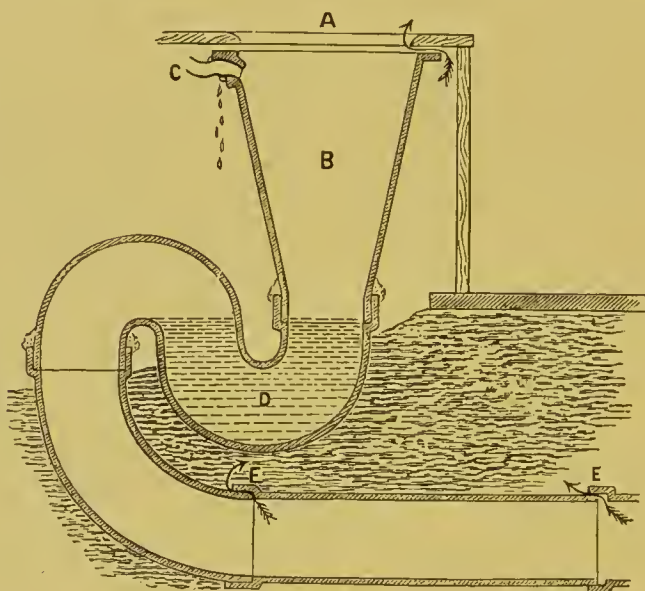
FIG. 55.

Fig. 55 shows in section a closet in the basement of a large semi-detached house in the suburbs. The closet was situated

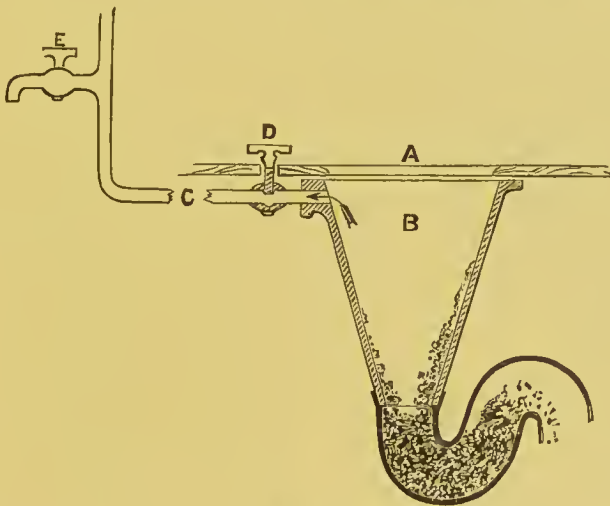
FIG. 56.

Fig. 56 is a section of a eloset directly served from the main. A is the soat, B the basin, C the serviee pipe, D the serew-down tap on this pipe, and E the tap over the sink-stone, served from the same pipe. This arrangement was very common some years back, and though I have been long doing my utmost to get owners to provide closets with separate serviee cisterns, examples of the defect are brought to notice every month. When a single watereloseet is flushed direct from the main the risk of fouling the town water (it may be with specifie germs) is eonsiderable, while

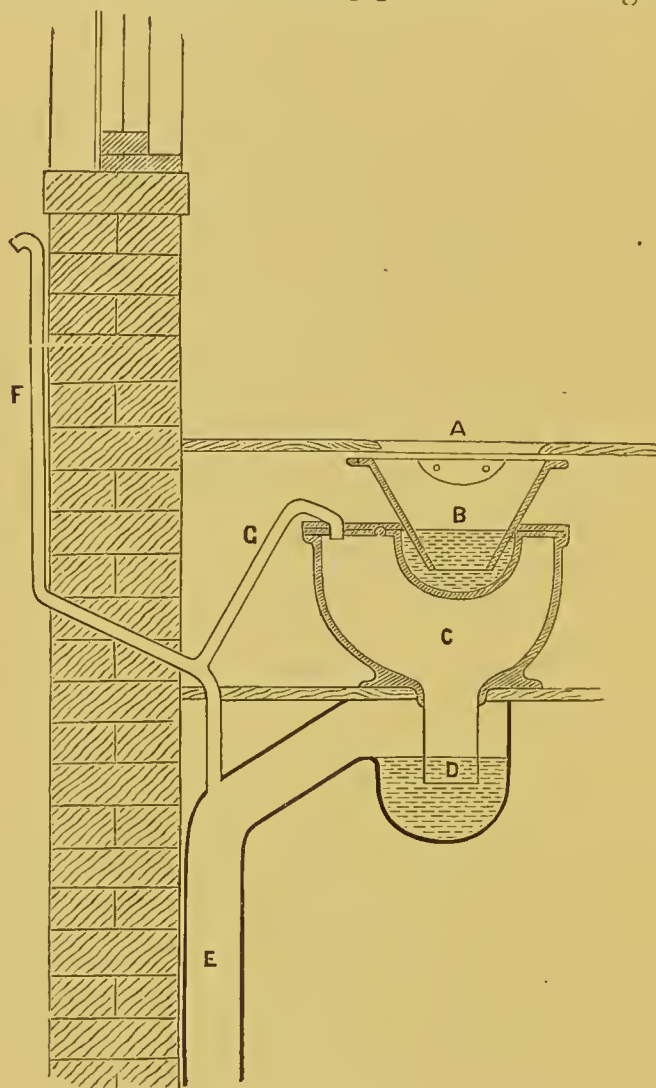
FIG. 60.

Fig. 60 explains itself. It gives a section of the closet fittings found in a large ecclesiastical residence, where what were alleged

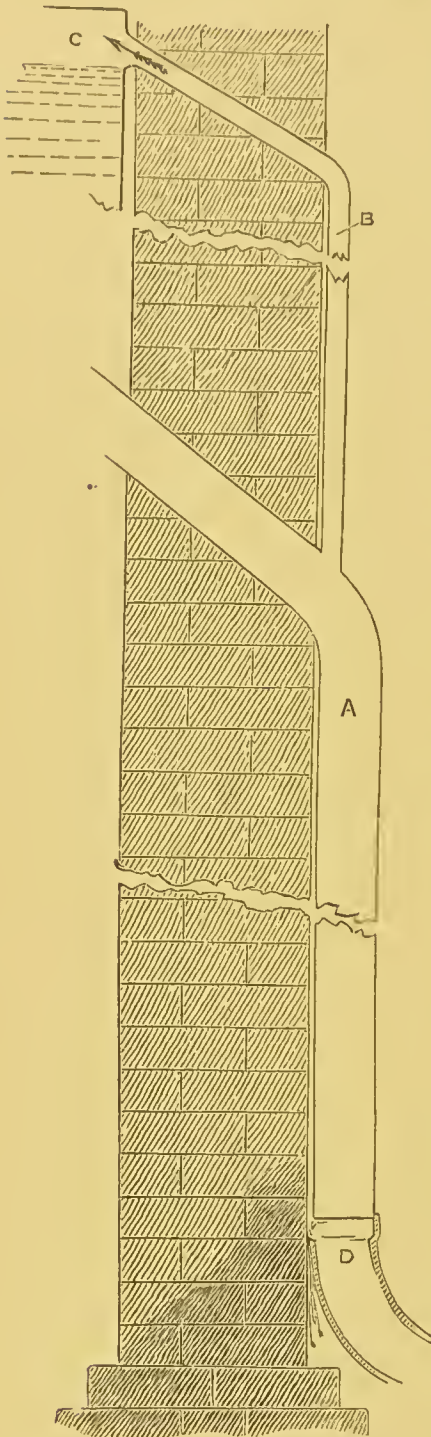
FIG. 69.

A correspondent sends me a sketch and description of a defect which he recently saw in an old house. (*Vide* Fig. 69.) Here is an unventilated soil pipe taken outside directly it leaves the watercloset, and as there is no proper connection between the soil pipe and house drain, filth is allowed to escape into the

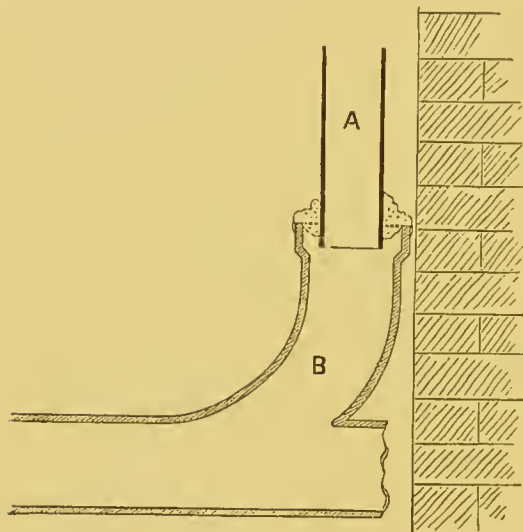
FIG. 71.

Fig. 71 represents a manner of connecting the soil pipe to the drain which I hope is exceptional in any town. To me it was certainly a new experience. Complaint was received of an effluvium nuisance in the front parlour of a small semi-detached villa, rented at about £20. On examination it was found that the soil pipe, which received also the bath waste, was carried into a 6in. earthenware junction pipe. The straight end of this pipe had been broken off in order to make it come close enough to the wall, and the broken end was *not stopped*. Of course, foul water penetrated through the wall just above the footings into the space beneath the parlour joists. A is the soil pipe and B the junction pipe.

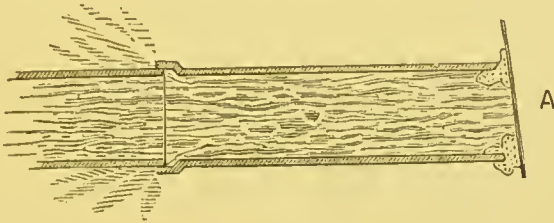
FIG. 75.

Fig. 75 illustrates the cause of a nuisance in a suburban villa. On inspection it was found that the 6 in. drain from the closet came to an abrupt termination close to the garden wall dividing this property from the next. The end of it had been deliberately closed up as shown at A, and the drain was full and leaking at some of the joints. A reference showed that two villas were built at the same time, and were allowed to drain together to the same sewer in front. Subsequently the villa in which the nuisance occurred was sold, and the other remained the property of the builder. It seems probable that about the date of the sale the vendor must have severed the drain from the villa he was selling, and reserved the drain running down his garden for the exclusive use of his own villa. A similar case was brought under my attention some time since. A drain serving two adjoining houses became frequently choked, and the tenants quarrelled about the payment of the charges made for cleansing it. Eventually the tenant of the garden in which the drain was situated cut off his neighbour's drain. Here, however, the disconnection was done openly and avowedly, and no attempt was made to close the end of the pipe, so that the resulting nuisance was manifest, and a separate drain was provided without delay.

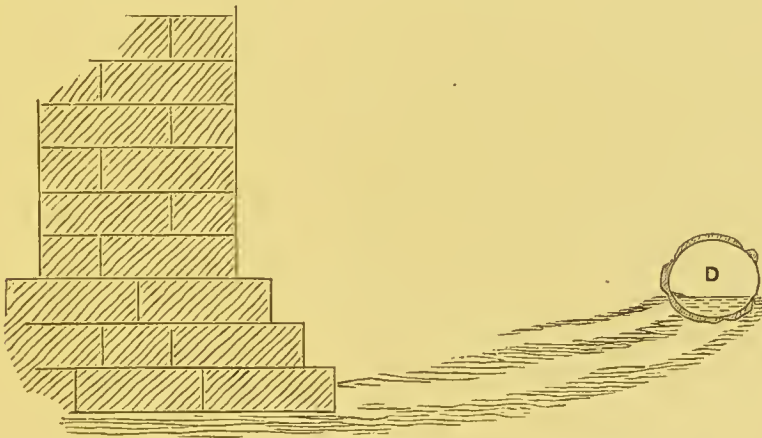
FIG. 76

Fig. 76 shows a defect in the drain of another suburban villa. Foul water was coming in through the wall and under the footings of the side of the house nearest the drain, and the drain was exposed and examined. Some of the 6in. glazed earthenware pipes D were found to be defective, the spigot ends having warped and got out of shape before being burnt, so that they would not slip into the flanges. Such pipes should, of course,

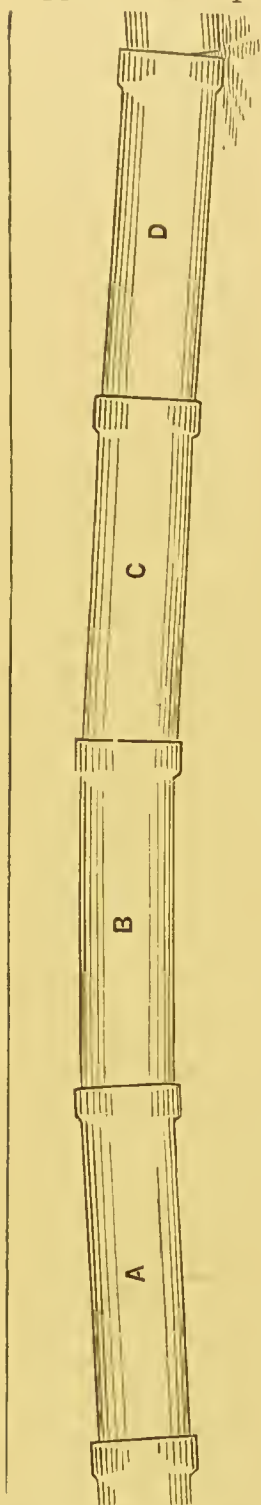
FIG. 77.

Fig. 77 shows a small portion in elevation. The horizontal line at the top indicates the level. Pipe A and the next to the left were about the fall intended, pipe B was dead level, pipes C and D were at different inclinations, the fall in both instances being the wrong way; beyond was a pipe with a slight inclination in the right direction. The joints were, almost without exception, imperfect, some allowing the contents to escape freely.

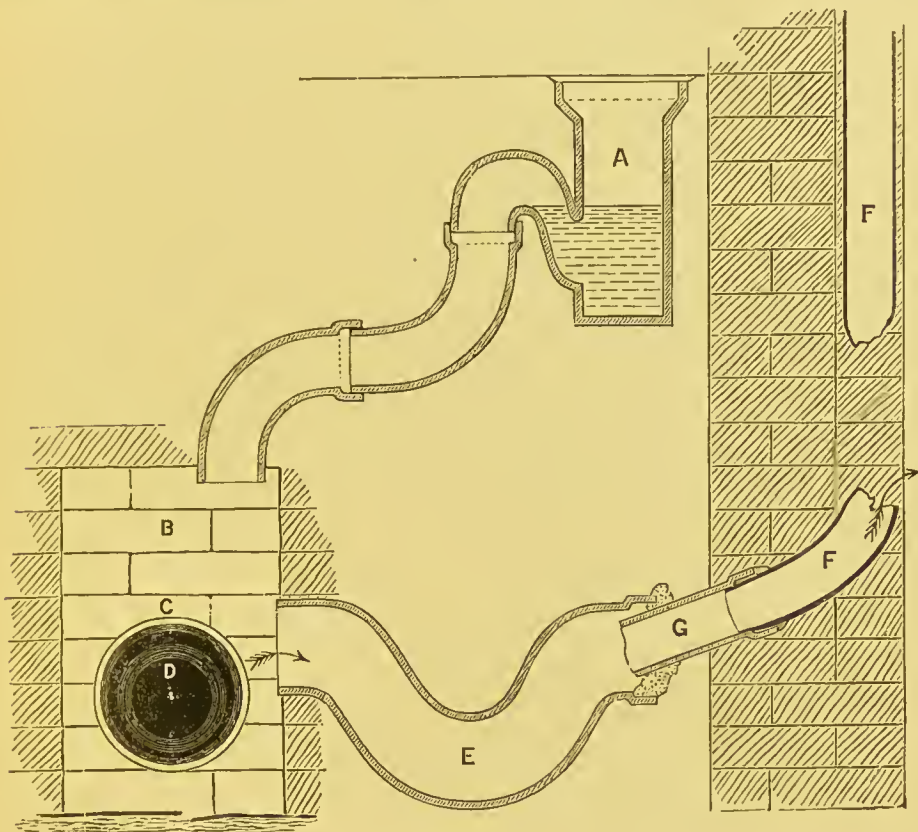
FIG. 80.

Fig. 80. A gully trap A, on which a waste pipe delivered, was brought into a cesspit B, loosely made with brick sides and a broken slate bottom; a 6in. earthenware pipe, as shown at E,

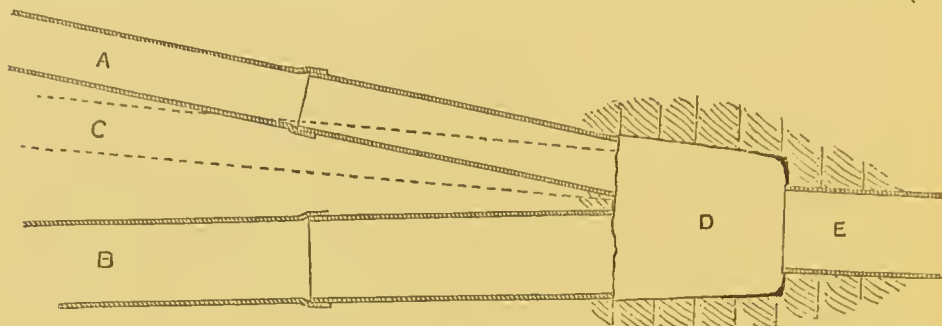
FIG. 81.

Fig. 81 represents defects in the drains in the basement of a large house I recently examined. A and B are glazed earthenware pipe drains, carrying slop water, and these, with C (an

old land drain just below A), are made to deliver into a small chamber D, and thence through the glazed earthenware pipe E. Drains should not be laid in the basement of a house, even if they only carry slop water. In this instance the joints were defective, and the flanged ends of the pipes all directed towards the outfall. However, the special defect to which attention is drawn by this illustration is connecting a land drain, roughly

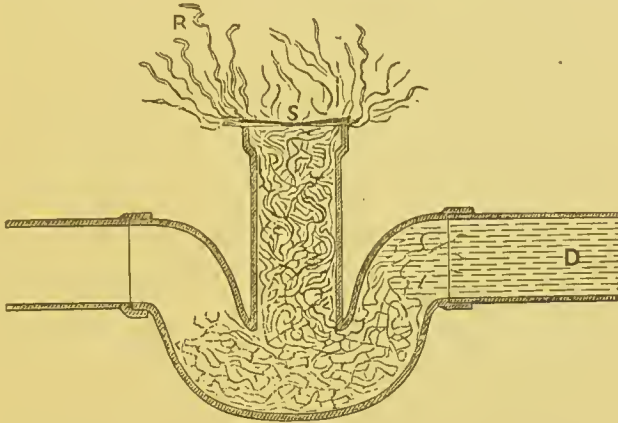
FIG. 83.

Fig. 83 represents the cause of a stoppage in a 6in. glazed earthenware pipe drain from a large house. The drain was laid
